Berkeley Mental Health Services Facility

MEASUREMENT & VERIFICATION REPORT

ZERO NET ENERGY SMALL COMMERCIAL RETROFITS (CEC EPIC 15-308)

March 2023

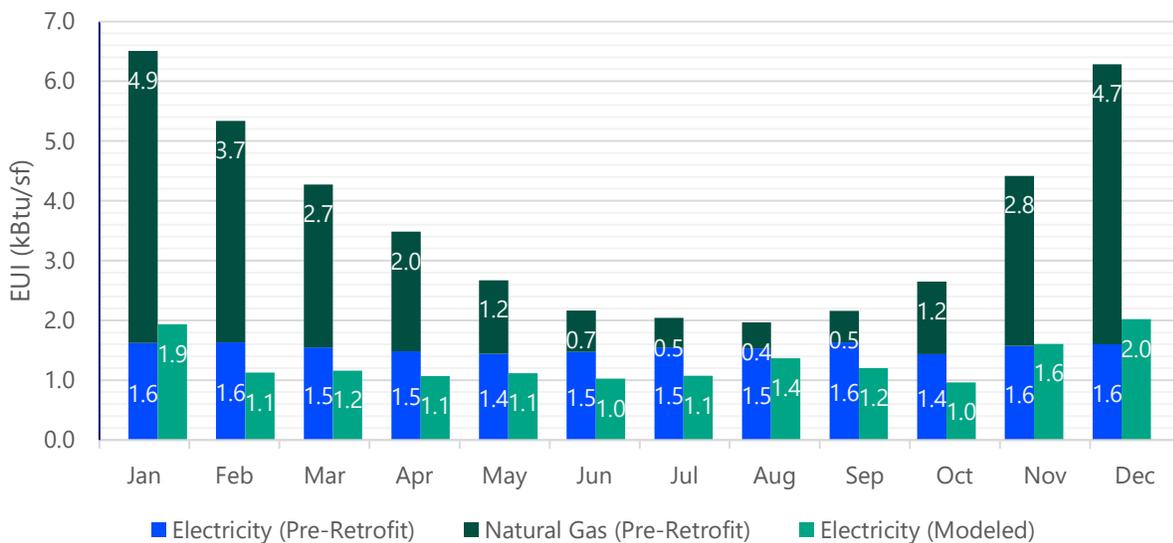
Figure 1 - Historical Energy Consumption vs Modeled Consumption

During the historical period, there were variations in occupancy and performance that are reflected in the utility data. The building had been vacant for some years before the retrofit work was conducted and there were mold issues due to issues with the dehumidifiers. The use of the average energy data over this period is considered to be a good approximation of typical energy use.

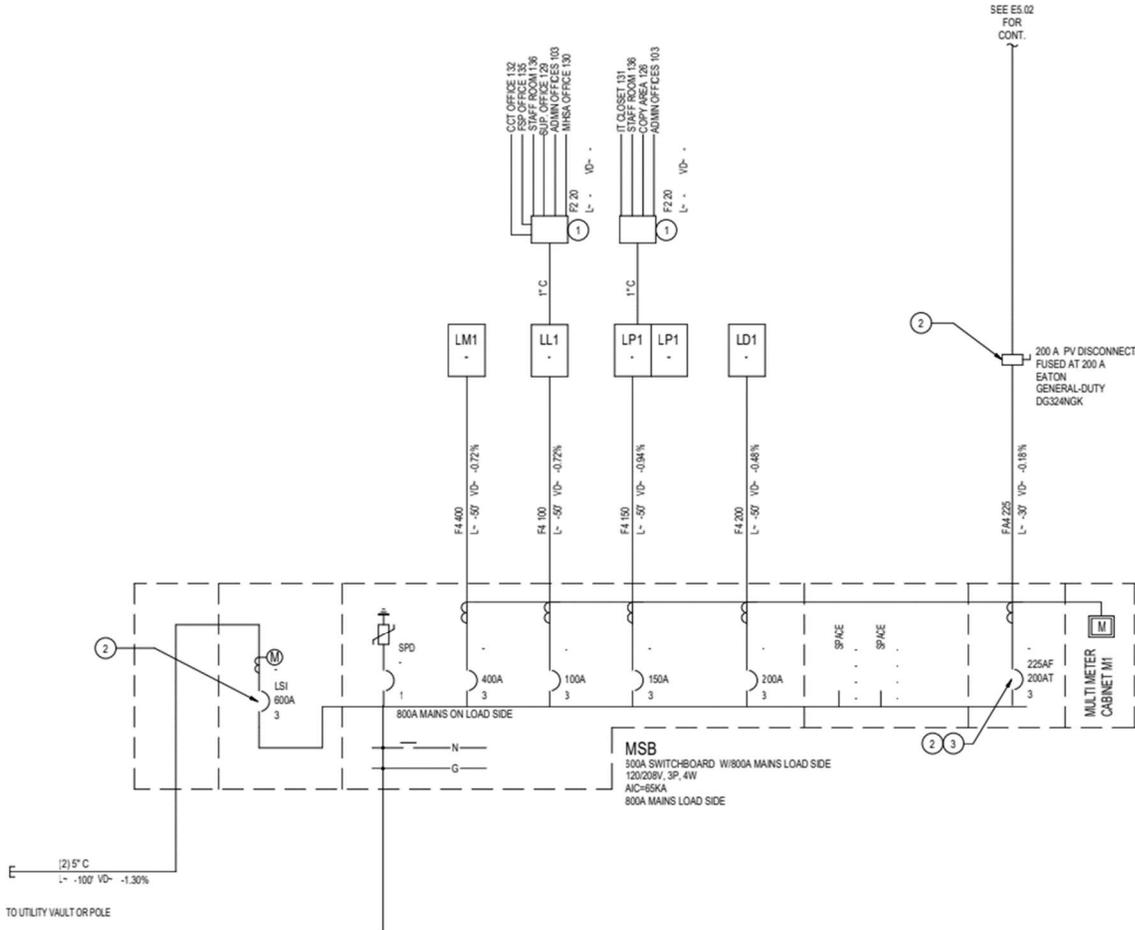
Figure 2 Electrical Single Line Diagram

To perform a more detailed analysis, the energy usage data was broken-down into end-use groups. The facility is equipped with meters that measure power usage at the electrical panel level and electrical current on targeted equipment (AHU-1; AHU-2; plug loads in the IT Closet (131), Staff room (136), Copy Area (126), and Admin Offices (103); and lighting in the COT Office (132), FSP Office (135), Staff room (136), MHSA Office (130), Admin Offices (103), and FIT Office (112)). Energy is separated by mechanical, lighting, domestic hot water, and plugs on the electrical panels and in the energy model.

Trend data was reviewed and compared monthly to modeled predictions. Large discrepancies in predicted and actual energy use were identified for the owner to address. An electrical single line diagram indicating the metering locations is in Figure 2.

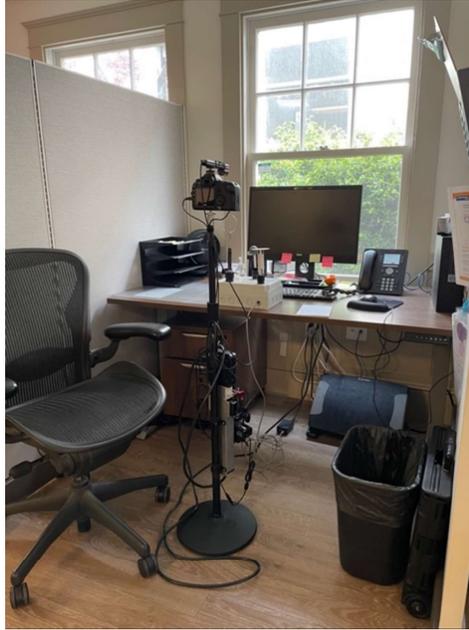
Figure 3 - Visual and thermal comfort measurement apparatuses deployed on site.

The visual comfort apparatus is mounted on a floor stand. The gray box visible on the desk is the thermal comfort apparatus.

Spot measurements of visual and thermal comfort variables were conducted in order to provide a quantitative assessment of occupant experience in the space after the retrofit was completed with an additional level of sensor data beyond that implemented in the retrofit. Visual comfort was assessed using the Daylight Glare Probability (DGP) metric [Wienold, 2006], based on measurements using high-dynamic-range (HDR) luminance mapping. It is generally considered desirable for DGP to remain below 0.3. HDR images were captured and processed by several custom apparatuses that were placed where occupants would normally face, with the camera lens at seated eye height (48 inches, also see Figure 3). Measurement locations are shown in Figure 4 - Locations for visual and thermal comfort spot measurements.

Apparatuses for measuring variables relevant to thermal comfort – dry bulb temperature, mean radiant temperature, relative humidity, and air velocity – were also deployed at similar locations. These measurements were used for calculating the Predicted Mean Vote/Percentage of People Dissatisfied (PMV/PPD) metric [ANSI/ASHRAE, 2013]. PMV provides a measure of how occupants are expected to perceive the space: values of -3, -2, -1, 0, 1, 2, 3 correspond to “cold”, “cool”, “slightly cool”, “neutral”, “slightly warm”, “warm”, and “hot” sensations, respectively. PPD is an indication of the percentage of people who would not be satisfied with the thermal environment. ASHRAE recommends that PPD be maintained under 20% and PMV between -0.5 and 0.5. Calculations were performed assuming an occupant metabolic rate of 1.3 met was assumed. This value can be considered an average level for work performed in an office [Akimoto, 2010]. Clothing insulation was assumed to be 0.61 clo – trousers and long-sleeved shirt (CBE ASHRAE-55 Thermal Comfort Tool [University of California, Berkeley, 2021]).

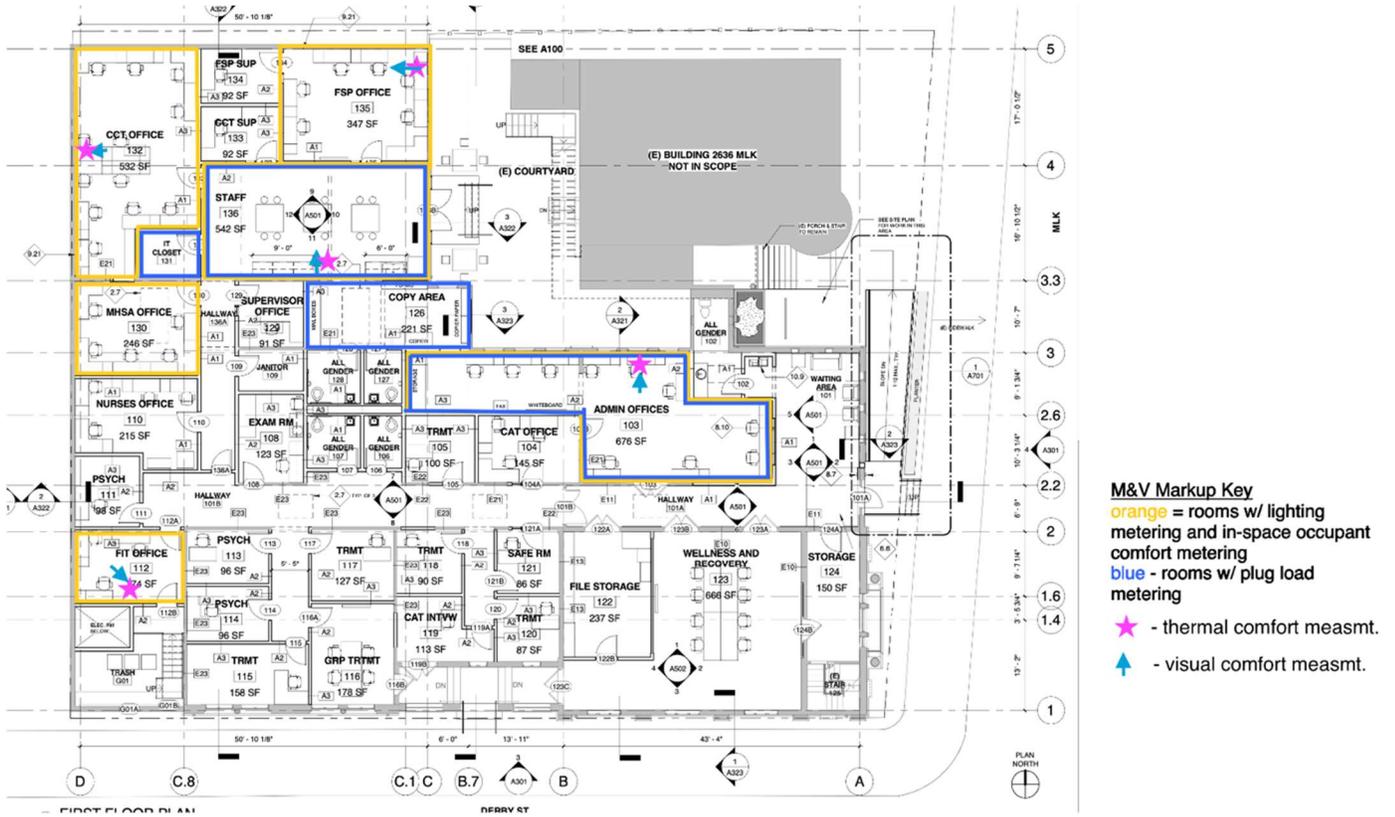
Figure 4 - Locations for visual and thermal comfort spot measurements.

The measurements took place at two different times of the year, in April and October 2022, in order to cover a variety of environmental conditions (weather, position of the sun). On each of these occasions, instruments were deployed on a Friday afternoon, collecting data over the weekend (i.e., while the space was unoccupied) until they were retrieved on the first workday following the weekend. Due to unforeseen equipment issues, thermal comfort data for the April site visit was unfortunately not available for analysis.

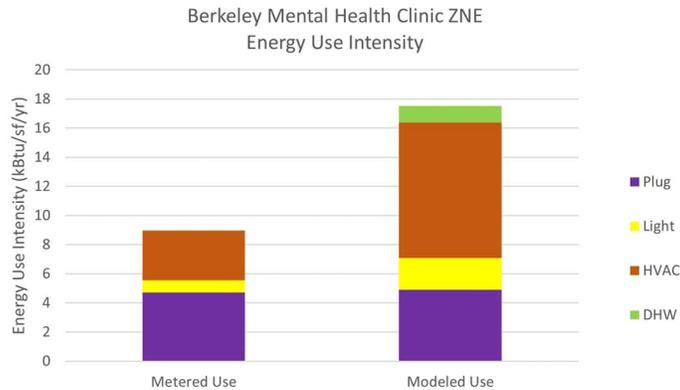
Figure 7 – Modeled vs Metered EUI

The total energy consumption for the building post-retrofit (without EV charging) was less than the predicted modeled data (79,130 kBtu/yr vs 137,439 kBtu/yr). For each end use, the metered energy use was less than the predicted modeled data, with a large variation in the amount of difference.

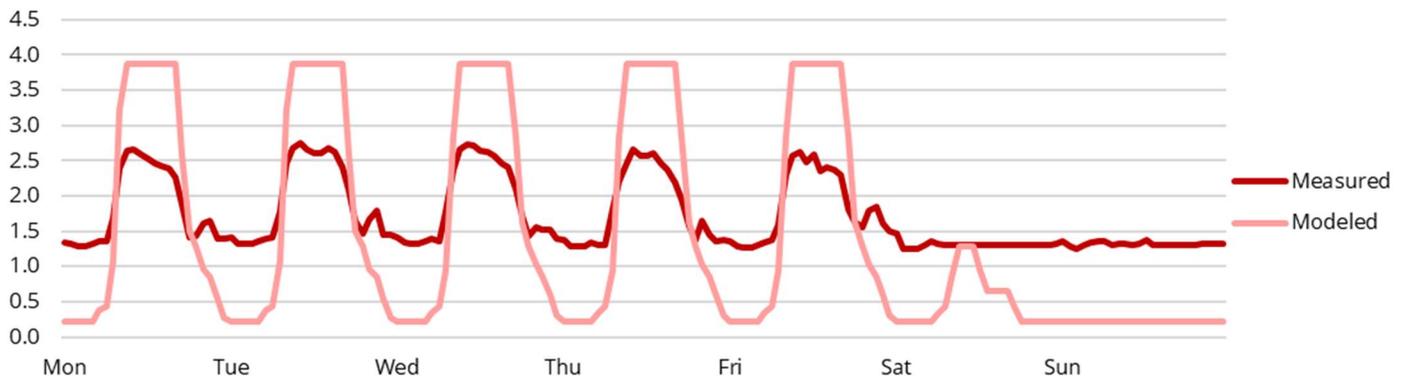
Figure 9 – Hourly Plug Load Electricity Consumption – Measured (March 2022) vs Modeled (March)

The metered plug load energy consumption (41,1474 kBtu/yr) is lower than the modeled plug load consumption (43,115 kBtu/yr), but not by a significant amount. When comparing the measured plug load consumption against the modeled data the first thing that is noted is that there is much less variation between the lows and the highs. When looking at the measured high-end hourly plug loads for Monday for example (2.7 kWh), it is noted that these are averages for all Mondays in the month of March which may help smooth peak consumption values. Additionally, it appears that the diversity in the utilization of the installed plug load equipment is lower than anticipated in the energy model, further reducing the daily plug load peak consumption.

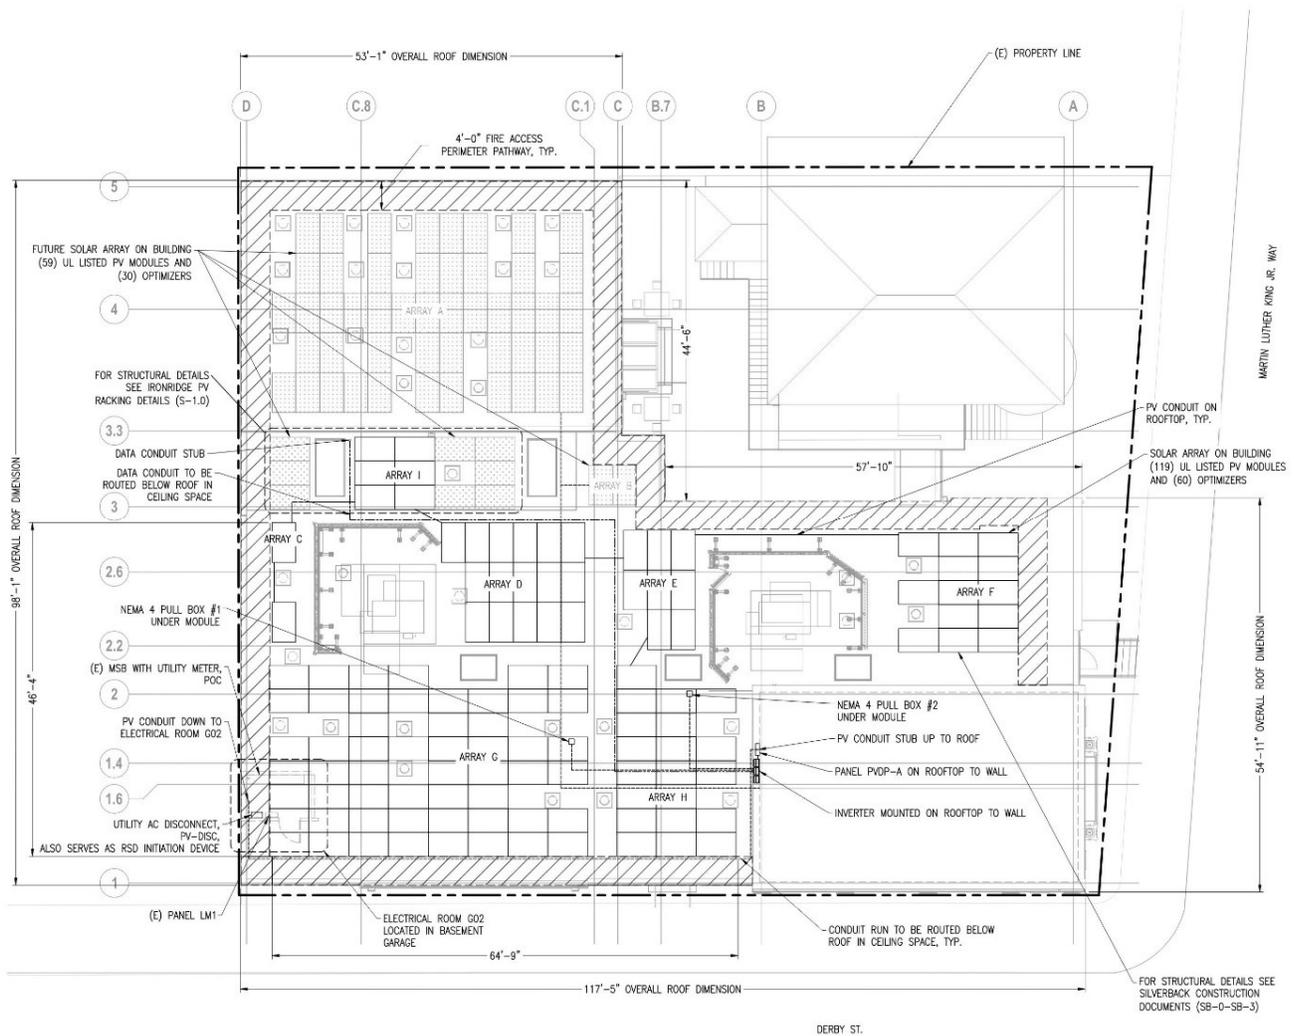
Figure 11 - PV System Layout

The PV system consists of 118 panels with a rated capacity of 340 W each for a total 40.12 kW DC capacity. The panels are installed at a 10-degree tilt in alternating directions, with 39 of the panels oriented north, 53 to the south, 12 to the east and 14 to the west. Note that Plan north is 30 degrees east of true north. There is minimal shading on the site from adjacent structures, however some shading from adjacent trees occurs.

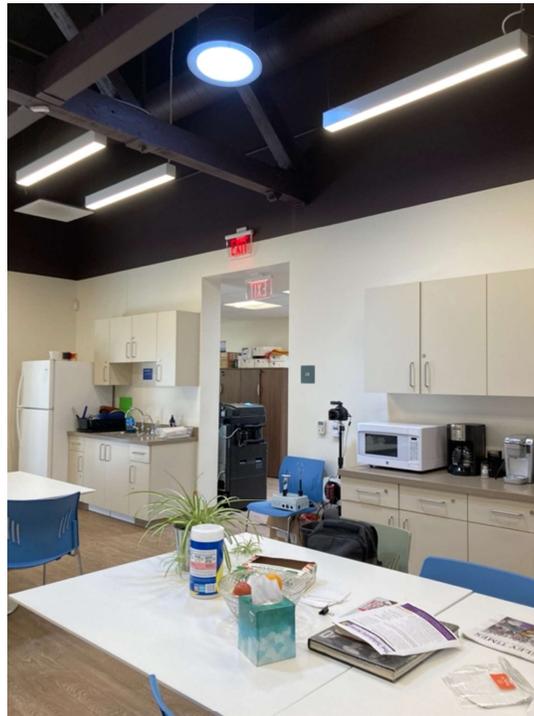
Measured visual comfort conditions were generally under the 0.3 Daylight Glare Perception (DGP) threshold for visual comfort. The highest DGP values were consistently measured in the kitchen (with several TDDs in the field of view; this measurement location is shown in Figure 13) and the reception (facing a window; this measurement location is shown in Figure 3) areas (see Figure 14 and Figure 15). In both locations DGP was kept under 0.3 during both site visits.

Figure 13 –View of the kitchen area showing visual and thermal comfort measurement apparatuses and one of the TDDs that was in the field of view of the visual comfort measurement.

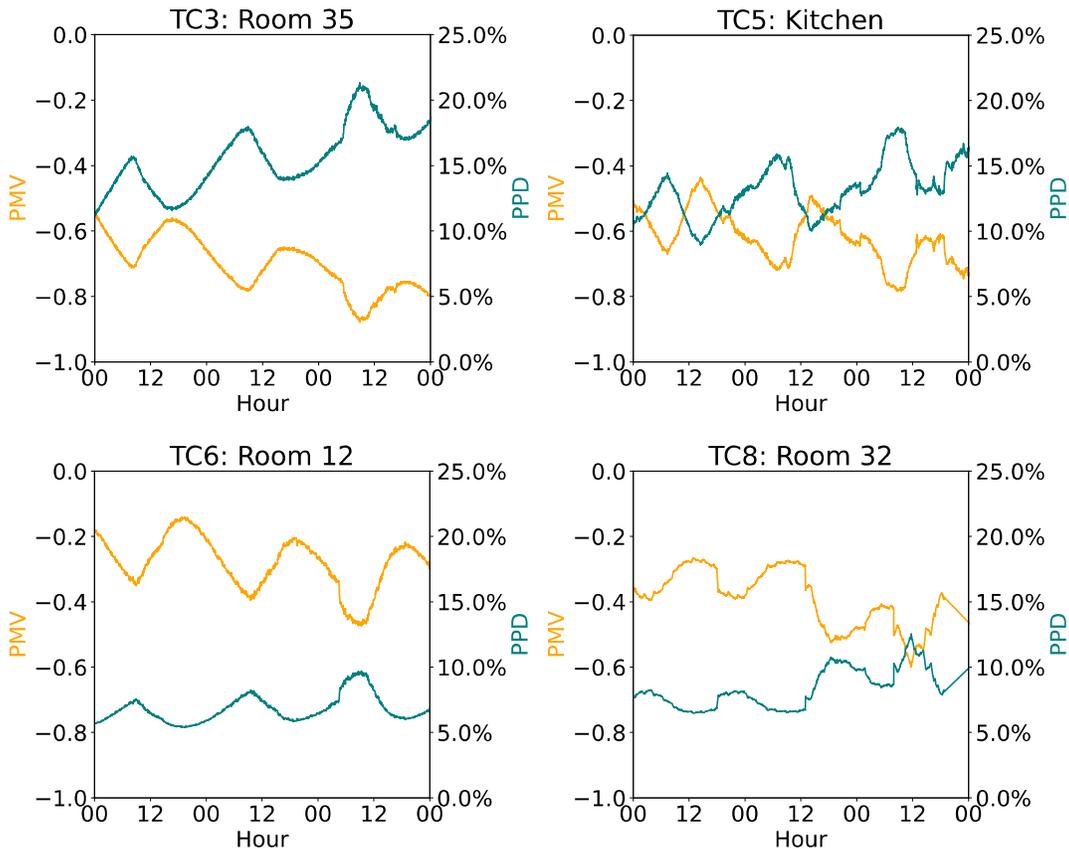
Results from thermal comfort measurements generally show comfortable conditions (Figure 16). Larger spaces (Room 32, kitchen, reception) approached the “slightly cool” rating of -1 PMV, with PMV reaching around -0.8 on two occasions. It should be noted that this happened on the third day of a long weekend, when the space had been unoccupied, and therefore devoid of the heat provided by occupants and other internal loads (e.g., office and kitchen equipment) for more than 48 hours; accordingly, the space would be expected to be warmer during normal operation of the building.

Figure 16 –PMV and PPD levels measured in the five measurement locations for three days in October.

Thermal comfort measurements when the building was empty indicated neutral to slightly cool conditions in the space, suggesting comfortable thermal conditions when the space is occupied.

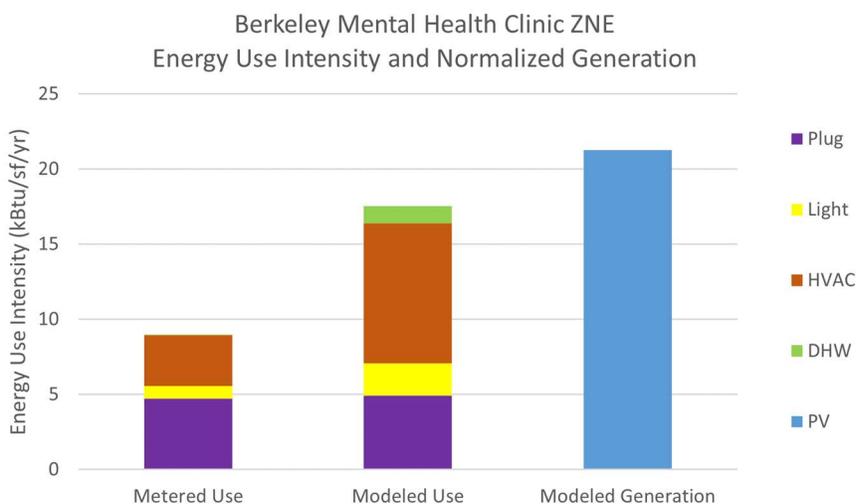
Figure 18 – Modeled vs Metered EUI vs Normalized Generation

It is expected that once the PV system is fully and correctly enabled net zero operation will be achieved, as the normalized modeled generation of 21 kBtu/sf/yr is significantly larger than the metered use of 9 kBtu/sf/yr. However this will not be confirmed until actual measurements of the system can be seen. If this does hold true, then there may be a significant opportunity for a large portion of the building stock to operate as net positive to compensate for building typologies (taller buildings and those with more intense loads) that are more challenging to retrofit to achieve net zero energy.
